American Inspections, Inc.
403 Stonehaven Lane NE
Cedar Rapids, IA 52402

Professional Home Inspection Report

SAMPLE INSPECTION REPORT
AMERICAN INSPECTIONS INC.
Cedar Rapids, Iowa City & Surrounding Areas
Call 319-377-9298

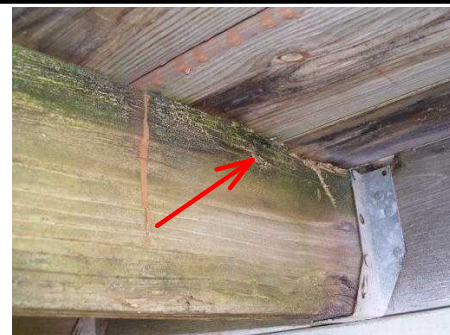
- Deck:** Treated wood Decay was noted at 6 of the deck's floor joists and rated defective at these joists. Recommend repair/replace damaged floor joists to provide proper support. Installation of sister joists along side of the decayed floor joists is one option of repair.
(See the included picture of one of the deck's damaged floor joist)

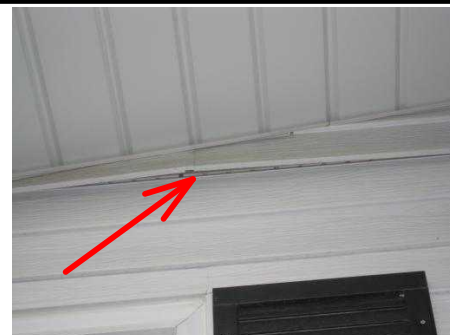
- Exterior Exterior Siding Type:** Vinyl 4 pieces of loose vinyl siding were noted at the South side of the dwelling. Recommend properly secure/repair loose siding for weather protection and to prevent siding damage with high winds. The balance of the siding appeared to be in functional condition.
(See the included picture of a loose piece of siding at the South eve area)

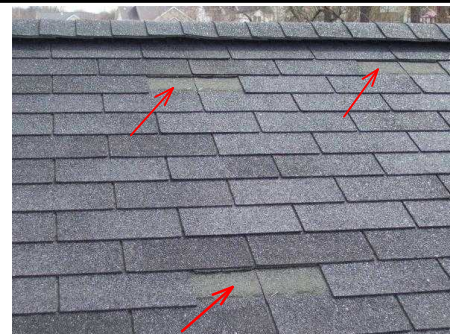
- Dwelling Roof Surface Material:** Composition Shingles 8 damaged shingles were noted at the dwelling's South roof surface. This may have been due to wind damage. These damaged shingles were rated defective. Recommend replace damaged shingles for weather protection. The balance of the dwelling's shingles appeared to be in functional condition.
(See the included picture of three of the damaged shingles)

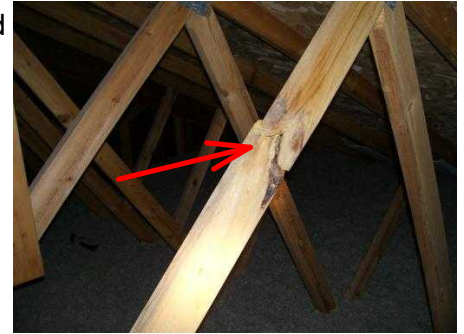
5. **Dwelling Attic Visible Roof Structure:** Truss A cracked truss was noted at the SW area of the attic and this truss was rated defective. Recommend a professional truss repair contractor make repairs to insure proper roof structure support. Trusses are part of an engineered roof structure system.

The balance of the visible truss roofing system appeared to be in functional condition.

(See the included picture of the cracked truss)

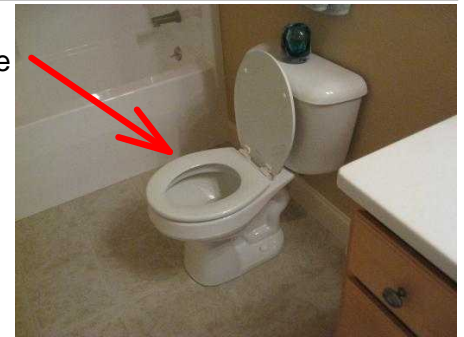
6. **Master Bathroom Toilet:** The toilet did not flush properly as if plugged/blocked and rated defective. Recommend a plumber inspect and make adjustments to provide a fully operational toilet.

(See the included picture of the non operational toilet within the master bathroom)

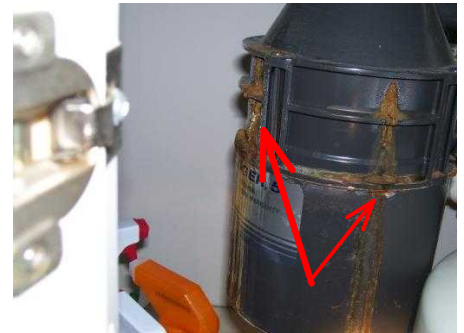
7. **Disposal:** Casing rust & leakage was noted at the garbage disposal at the time of the inspection and rated defective. Recommend replace the garbage disposal to provide an operational unit and to prevent water damage to the kitchen cabinet.

(See the included picture of the defective garbage disposal)

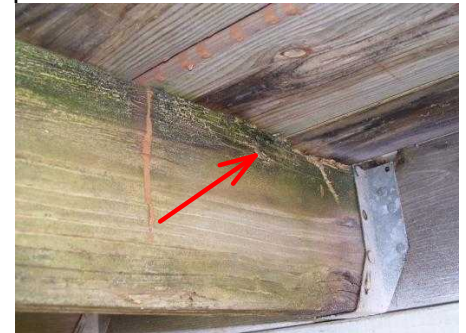
7. Priority Item, Defective **Deck:** Treated wood
Decay was noted at 6 of the deck's floor joists and rated defective at these joists. Recommend repair/replace damaged floor joists to provide proper support. Installation of sister joists along side of the decayed floor joists is one option of repair.
(See the included picture of one of the deck's damaged floor joist)

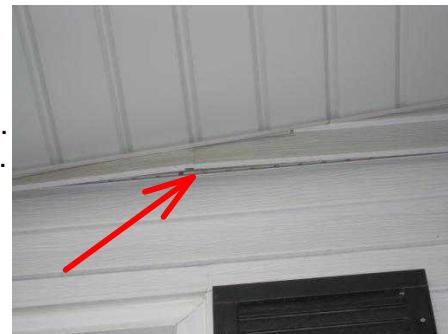
3. Priority Item, Defective **Type:** Vinyl
4 pieces of loose vinyl siding were noted at the South side of the dwelling. Recommend properly secure/repair loose siding for weather protection and to prevent siding damage with high winds. The balance of the siding appeared to be in functional condition. (See the included picture of a loose piece of siding at the South eve area)

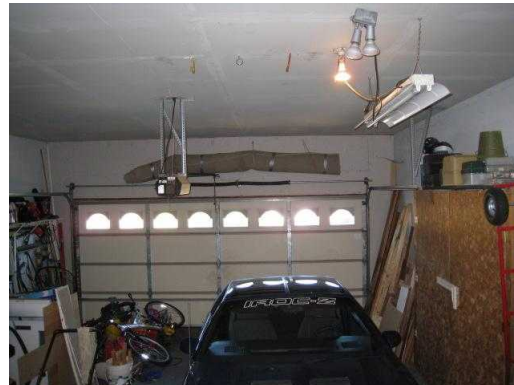
Portions of the garage were not visible due to storage and a parked car. Comments based on limited visible surfaces. Recommend inspect when clear of storage.

(Included is a picture of the garage and stored items limiting the view for inspection)

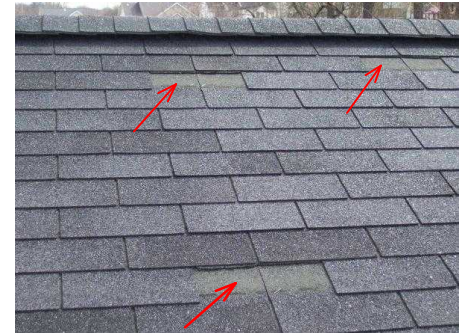
3. Priority Item, Defective Material:

8 damaged shingles were noted at the dwelling's South roof surface. This may have been due to wind damage. These damaged shingles were rated defective. Recommend replace damaged shingles for weather protection. The balance of the dwelling's shingles appeared to be in functional condition.

(See the included picture of three of the damaged shingles)

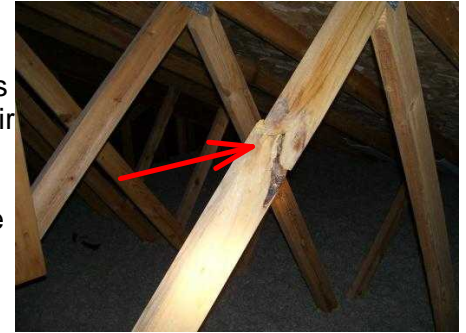
1. Priority Item, Defective Visible Roof Structure:

A cracked truss was noted at the SW area of the attic and this truss was rated defective. Recommend a professional truss repair contractor make repairs to insure proper roof structure support. Trusses are part of an engineered roof structure system.

The balance of the visible truss roofing system appeared to be in functional condition.

(See the included picture of the cracked truss)

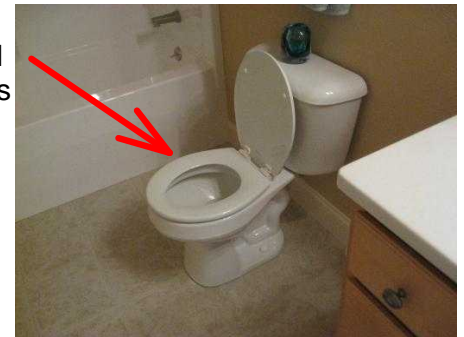
The toilet did not flush properly as if plugged/blocked and rated defective. Recommend a plumber inspect and make adjustments to provide a fully operational toilet.

(See the included picture of the non operational toilet within the master bathroom)

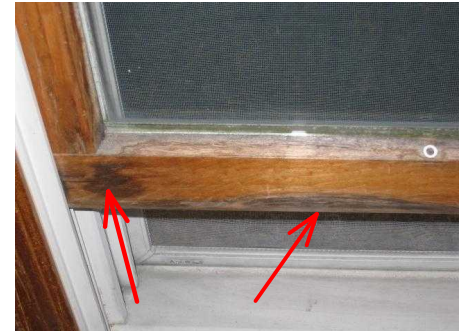
Most of the windows showed some frame wear/discoloration. Recommend maintenance refinish for weather protection. The windows had thermopane glass in place for added energy efficiency.

(See the included picture of the window frame wear/discoloration)

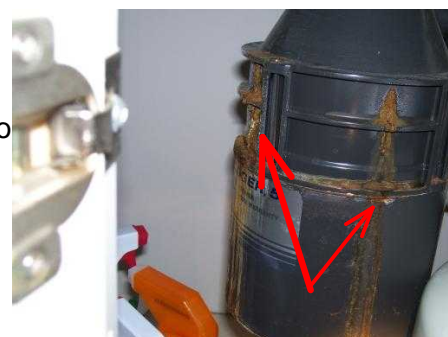
1. Functional **Kitchen Stove:** Electric
 The stove's oven, broiler, and stove top heating units responded to the main heating controls when set on the high setting.
2. Functional **Vent Fan:** Re-Circulating Fan
 The vent fan was the re-circulating type which vents through a filter into the kitchen area versus to the exterior which is a common installation. Recommend maintenance wash/replace the filter as needed.
3. Functional **Dishwasher:**
 The dishwasher was run through a normal cycle and appeared to be functional at the time of the inspection.
4. Priority Item, Defective **Disposal:**
 Casing rust & leakage was noted at the garbage disposal at the time of the inspection and rated defective. Recommend replace the garbage disposal to provide an operational unit and to prevent water damage to the kitchen cabinet.
 (See the included picture of the defective garbage disposal)
