American Inspections, Inc.
403 Stonehaven Lane NE
Cedar Rapids, IA 52402

Professional Home Inspection Report

SAMPLE INSPECTION REPORT
AMERICAN INSPECTIONS INC.
Cedar Rapids, Iowa City & Surrounding Areas
Call 319-377-9298

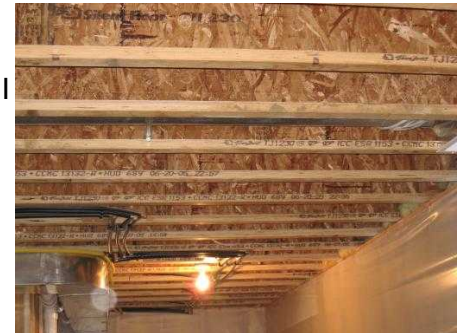
5. Functional	Visible Floor Joists:	I-Joist
	Estimate % Visible:	70%
	The visible floor joists were the manufactured wooden laminated I joist type. (Included is a picture of the engineered floor structure system for reference purposes.)

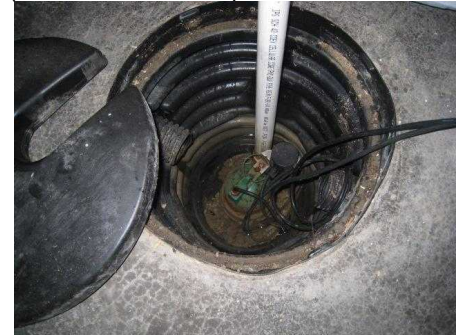
The sump pump responded to raising the float. Recommend maintenance test the sump pump monthly to insure it remains fully operational.

(Included is a picture of the sump pit and pump for reference purposes)

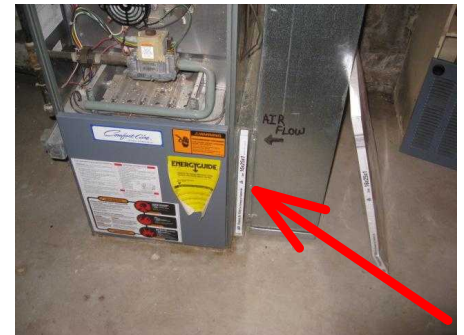
(Included is a picture of the furnace with the upper service panel cover removed for inspection & the filter access position is marked for reference purposes.)

Recommend maintenance replace the furnace filter monthly.

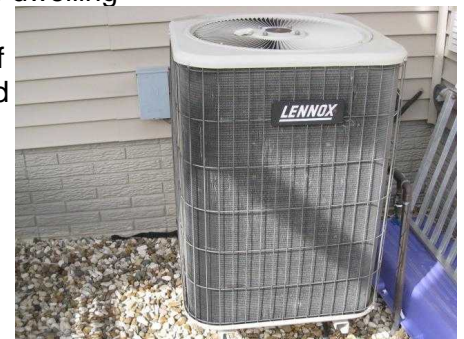
The central air conditioning system was operational at the time of the inspection. The air temperature at a cold air supply line tested approximately 50 degrees F. when the A/C was in operation. A temperature drop over the evaporator coil of 20 degrees F. was noted. The A/C was operating within general acceptable temperature drop guidelines for its age and years in service.

(Included is a picture of the exterior A/C unit for reference purposes)

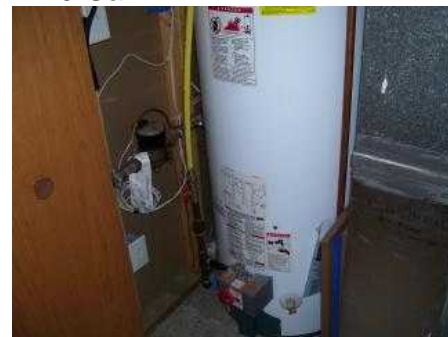
The hot water temperature tested 120 degrees F. at the kitchen sink with the water heater's temperature control set on a medium setting. (120 of is recommended as a safe/conservative temperature for the safety of small children) Recommend monitor/maintain the water temperature.

(Included is a picture of the water heater for reference purposes)

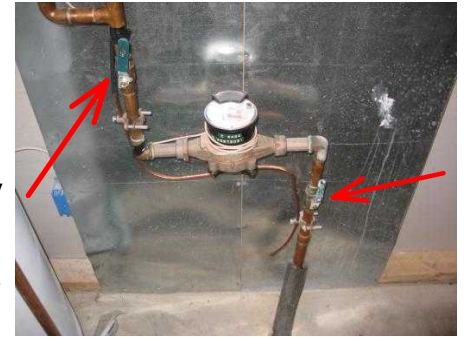
(Included is a picture of the main plumbing shut off valves for reference purposes.)

The main shut off valve is not operated to avoid the potential for post inspection leakage. Recommend operate this valve annually but be prepared to replace/repair the valve if leakage or failure occurs.
